THE RISKS OF ŠKODA¹

Unsettling facts on the Temelín Nuclear Power Plant

concerning faulty welding work and documentation in Temelín block 1

Fact sheet, version 5.0²

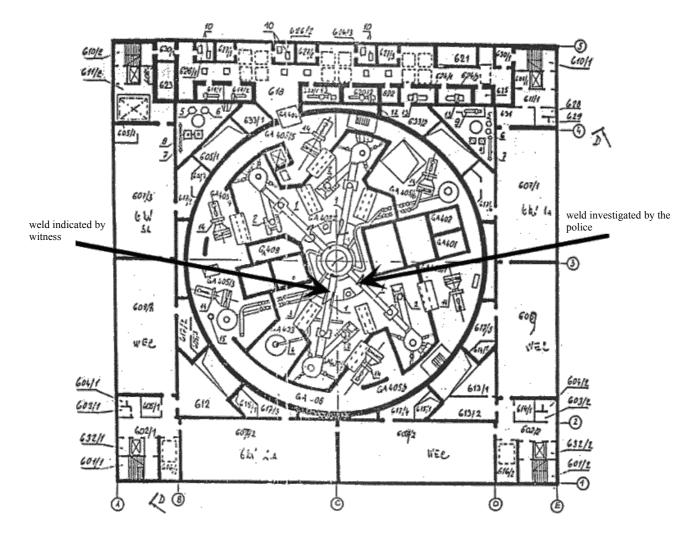
Photocopy of the pipe lay-out drawing in the hands of SUJB

- 1. In July 2000, an anonymous witness¹ informed the Czech office of Greenpeace that while working on the Temelín construction site, he participated in a repair of one of the welding seams directly between the primary cooling circuit and the reactor of block 1 of the Temelín nuclear power plant. He claims that the main pipe was connected 180° wrong. This was discovered only after the welding work on the pipe was virtually finished. Modranská potrubní a.s. ordered the welding teams to cut directly on the seam on the reactor vessel, turn the pipe and re-weld it. He claims that documentation must have been adapted to hide this case. He also claimed that this procedure was against technical regulations and that the responsible companies - the subcontractor Modranská potrubní a.s. and main contractor Škoda Praha a.s. – agreed on keeping this incident secret. On request of the police, CEZ and SUJB, the witness identified to Greenpeace the welding seam on a map provided by CEZ. This information was passed on to SUJB on 22.9.2000 during a meeting between Jan Haverkamp and Jiří Tutter of Greenpeace and SUJB president Ing. Dana Drabova and SUJB inspector Ing. Jana Kroupova. The indicated welding seam was later identified by SUJB as the seam number 1-4-5.23

This is a photocopy of the drawing that was handed over to SUJB during a meeting with SUJB president Dana Drabova and inspector Jana Kroupova on 22.09.2000.
