Wiesbaden, August 2013

Potential weak spots in the primary circuit in Block 1 of the Temelin nuclear plant in the Czech Republic

Short advisory statement on behalf of the Alliance 90/The Greens parliamentary
group in the Bundestag

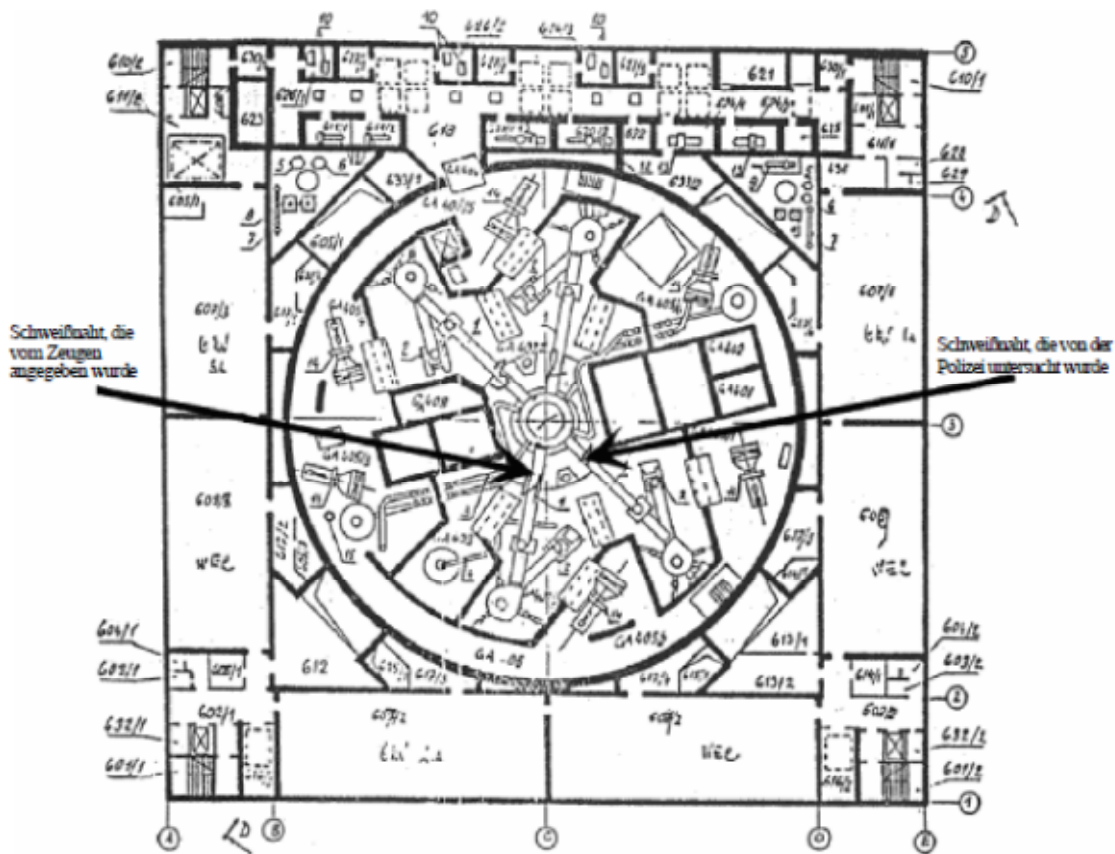
This is a copy of the diagram that SUJB received during a meeting held on 22 September 2000 and attended by SUJB president Ms Drabova and the inspector Ms Kroupova. The black arrow on the left indicates the weld that the witness identified. The one on the right shows the weld that the police investigated.
